# **Repair, Restoration & Retrofitting of Subhashnagar Govt. Primary School, Gopeshwar, Chomoli Dist., Uttarakhand Project Completion Report**

## **Background**

January 31, 2014

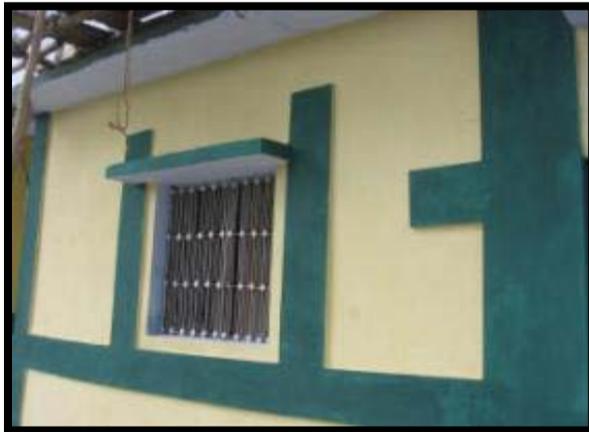
Exterior of Room 1

- **Strengthening of Room 1 Entrance:** The beam supporting the passage slab next to the front wall of Room 3 at the junction with Room 1 appeared to be resting on the lintel of the door of Room1. The lintel in turn does not appear to have adequate support in the wall of Room 2, is sitting squarely on the steel door frame. In other words the roof slab of the passage and the beam that it is sitting on appears to be resting on the door frame. Hence, a new heavier frame was installed as a supplemental support to the passage beam. The new frame was anchored to the walls with 6" long nails.

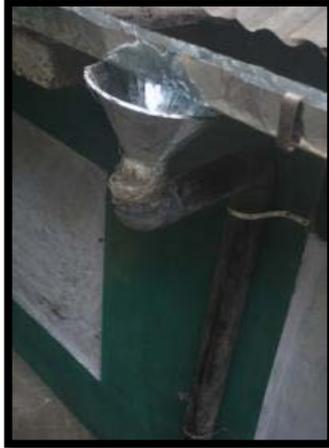
Roof rain water gutter in rear

- Roof gutter was installed at the eave level of the pitched roof over Rooms 3 and 4 along the rear wall to prevent splashing of rainwater falling off the pitched roof. In front, along a part of the eave of Room 3 adjacent to the Room 7 5' long roof gutter was installed to prevent water from the CGI roof over Room 3 to leak down at the junction between the passage roof slab and wall of the two storey building.
- Along the full front eave GI eave board was installed at the front end of the rafters to minimize rainwater splashing in to the joint between the passage roof slab and front walls of Room 3 and 4.
- In the CGI roof of Rooms 3 and 4 all the open holes and nails without tar-felt washers were sealed with a special Areldite sealant, all the J-bolts without washers were removed and replaced with washers, the ridge was resealed with a new layer of adequately wide GI sheeting.

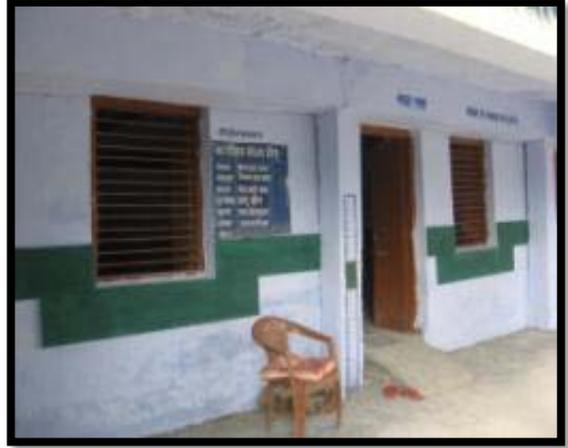
Exterior of Room 3 in retrofitted school

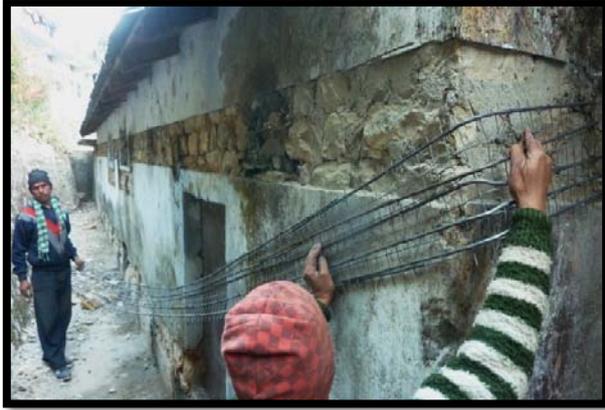
Installing WWM belt

- **Seismic Belts:** Since in the main three rooms the seismic bands are absent in the walls, in lieu of them the Seismic Belts made of Welded Wire Mesh (WWM)

encased in 1:4 cement mortar are installed at sill and lintel levels. In addition since two of these rooms have pitched two sided Corrugate Galvanized Iron (CGI) sheeting roof seismic belts are also installed just little below the top of the gable walls. All these belts are installed on both faces of the walls. In some rooms where lintel level belt is present, then only the sill level belt is installed. All the belts are securely attached to the walls.

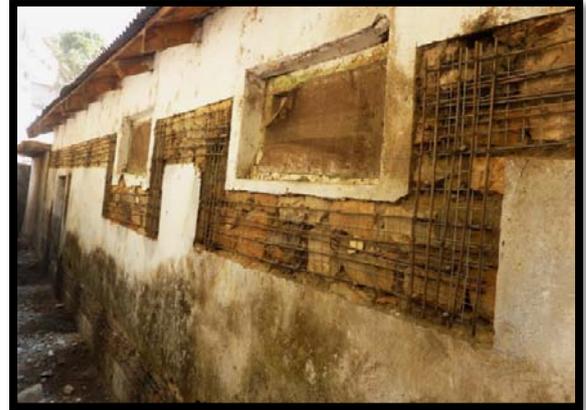
Installed WWM belt

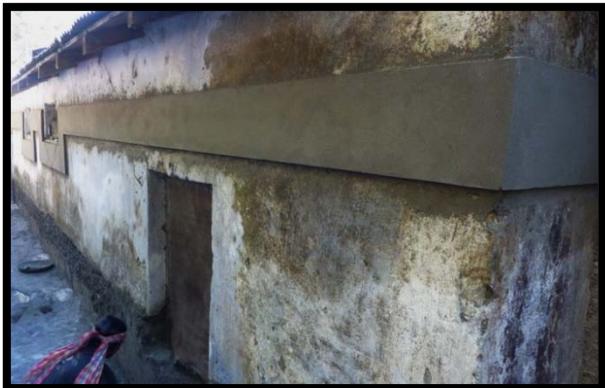
WWM belt on wall plastered and finished
