**Case Studies of Seismic Retrofitting –  
Latur to Kashmir  
&  
Lessons Learnt**

**International Conference On Construction  
“Managing Earthquake Risk”**

By:  
Rajendra Desai, Hon. Director  
National Centre for Peoples’-Action in Disaster Preparedness  
(NCPDP)  
Ahmedabad, Gujarat, India

Four case studies are taken in this paper. This includes (a) a house in a village in Latur region, (b) a Road & Building Department Office cum Storage building in a small Gujarat town, (c) a small school in mountainous border region of Kashmir, (d) a large 3 storey school of Delhi Municipal Corporation. **The author was involved in the conceptualization as well as the execution of each one of these projects.**

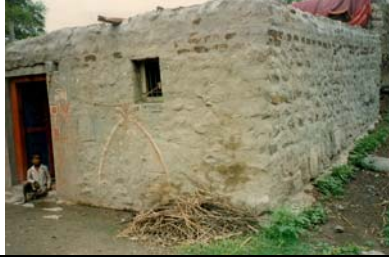
Retrofitting & Restoration completed	Knee braces at beam-column joint

**Retrofitting Measures:** Restoration of damages followed by (a) Stitching of stone wythes with Cast in-situ RC Stitching Elements, (b) Installation of roof level RC Band after removal of the upper part of the walls including the projection above the roof, (c) Installation of Knee Braces at the junction of timber columns and beams.

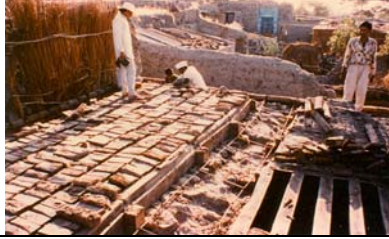
Upper Wall removed for band installation & Roof deck opened for repairs	Cast in-situ RC Stitching Element being plaster

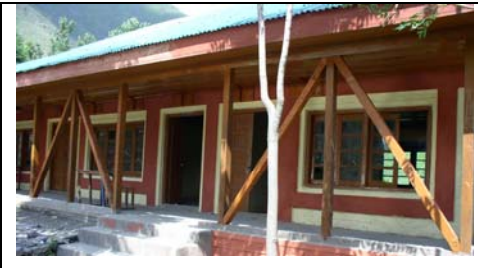
<p>Retrofitting completed with bracings between columns</p>	<p>Roof to Wall Anchoring</p>

**Retrofitting Measures:** (a) Stitching of stone wythes with Cast in-situ RC Stitching Elements, (b) WWM Seismic Belt at eave level, (c) Vertical Reinforcing Bars in corners anchored to walls and encased in micro concrete, (d) Encasing of wall openings with WWM Seismic Straps, (e) Roof diaphragm improvement with the installation of timber bracings and struts, (f) Strengthening of connections between roofing elements, (g) Anchoring of attic floor to walls with the help of vertical rebars and special MS brackets, (h) Diagonal timber bracings between timber columns in verandah. And (I) Restoration of earthquake damage

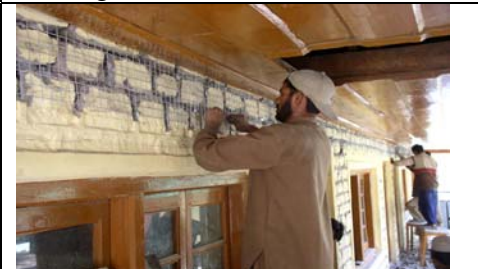
<p>Installation of WWM for Lintel level Seismic Belt</p>	<p>Seismic Belt &amp; Opening Encasement</p>

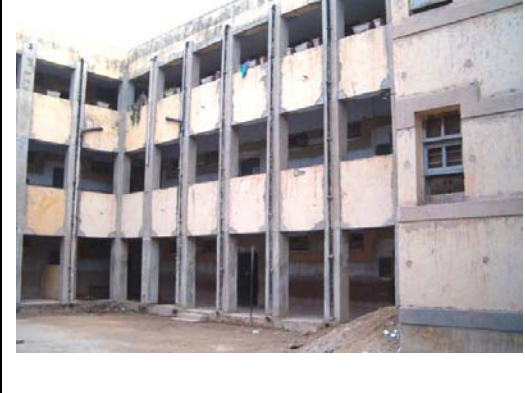
<p>Jacketed Masonry Columns &amp; Seismic Belts</p>	<p>Jacketing reinforcement</p>

**Retrofitting Measures:** (a) WWM Seismic Belt at lintel and sill levels, (b) Vertical Reinforcing Bars in corners anchored to walls and encased in micro concrete, (c) Encasing of wall openings with WWM Seismic Straps, (d) Anchoring of slabs to walls, and (e) Jacketing of masonry columns

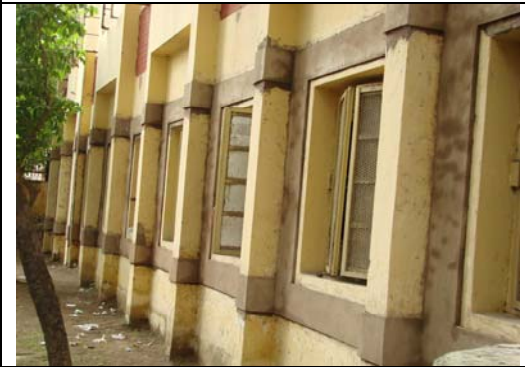
<p>Lintel &amp; Sill Belts &amp; Window Encasement</p>	<p>Encasement of door way</p>
