**Transfer of Earthquake Resistant Building
Technologies At Grassroots in Kashmir**

Rajendra Desai, Structural Engineer

**International Conference on
Earth Construction**

August 23, 2007

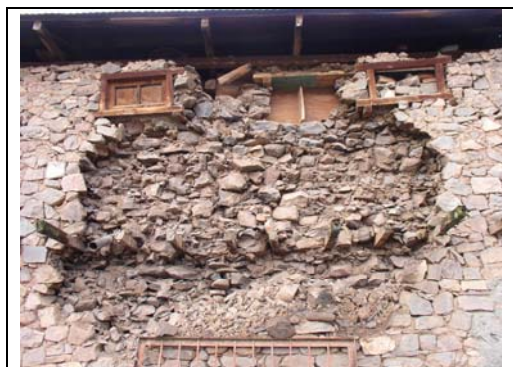
Delamination of UCR wall

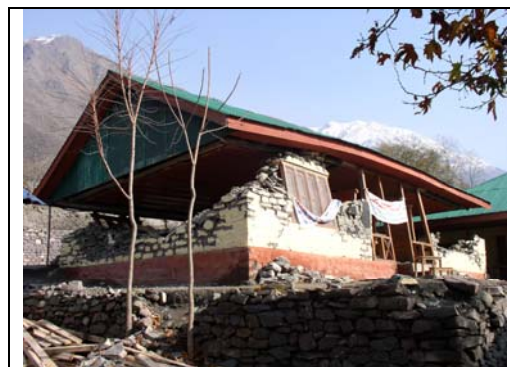
Collapse of UCR wall

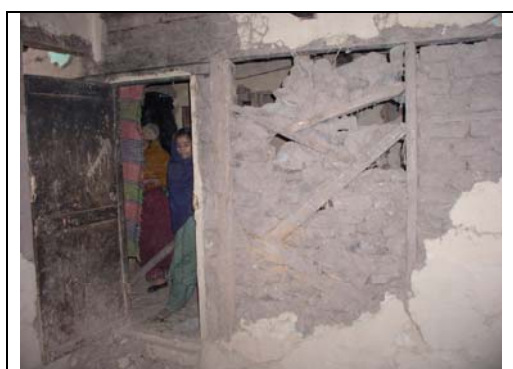
Damage to *Dhajji* wall infill

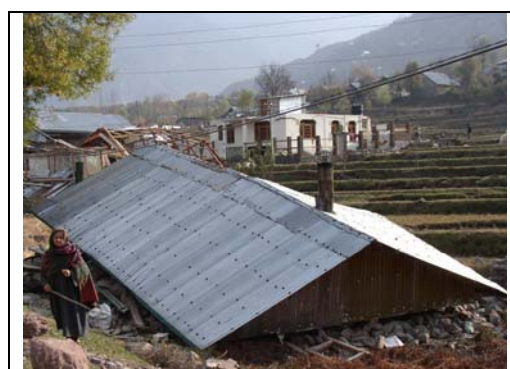
Roof box lying on ground

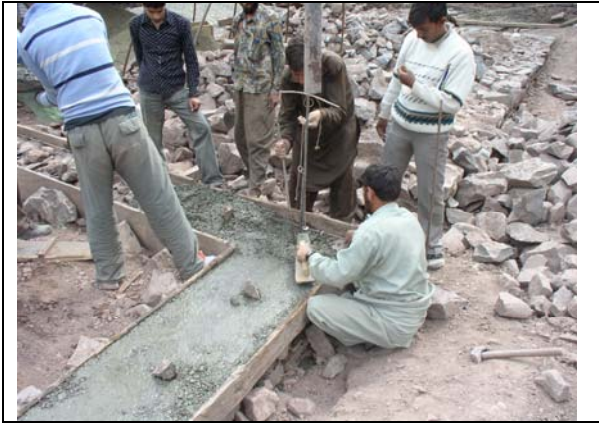
Shear keys on top of RC Band

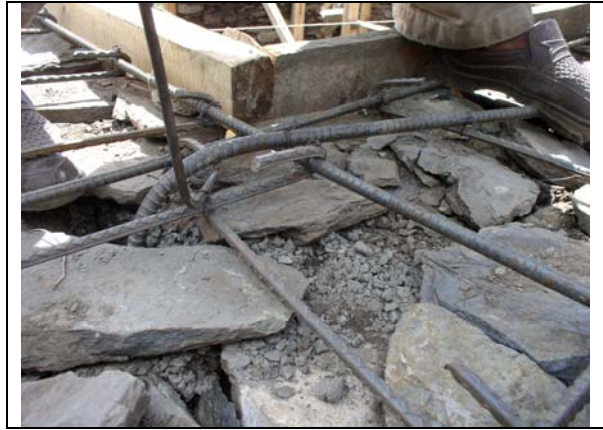
Connecting vertical reinforcement to RC Band

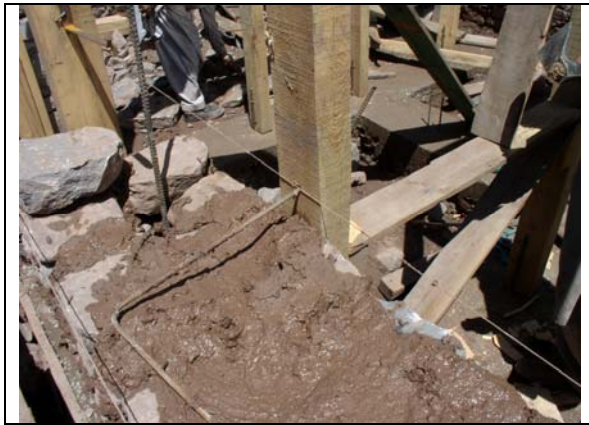
Dhajji wall anchor to UCR wall

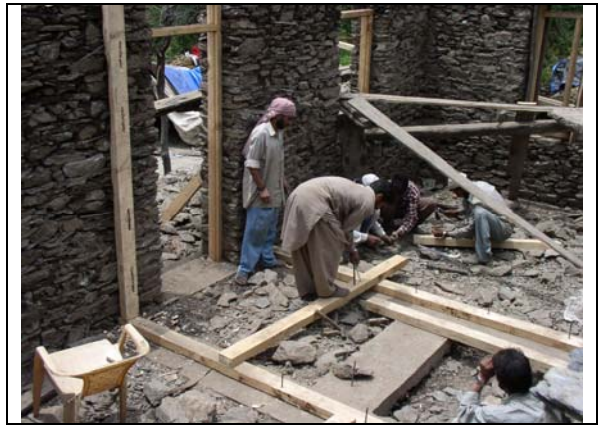
Dhajji wall anchored to Band & UCR Wall

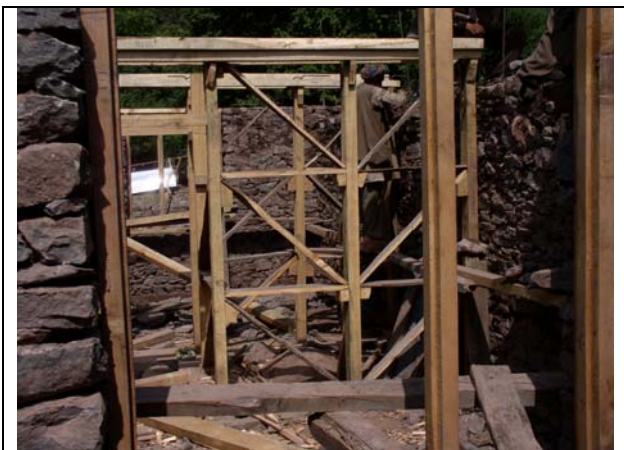
Dhajji wall with continuous bracings and improved connections

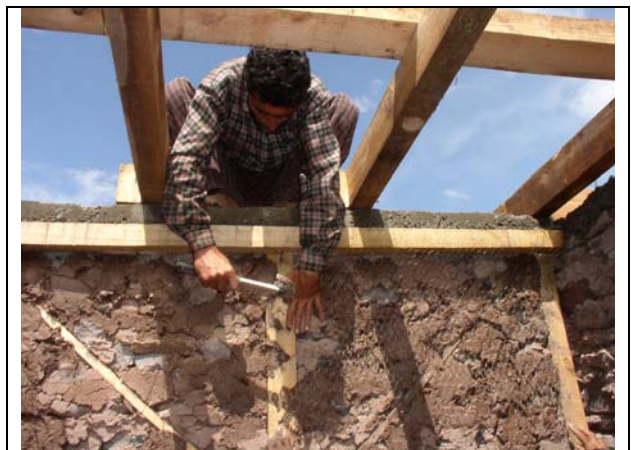
Chicken Wire Mesh confinement on *Dhajji* wall

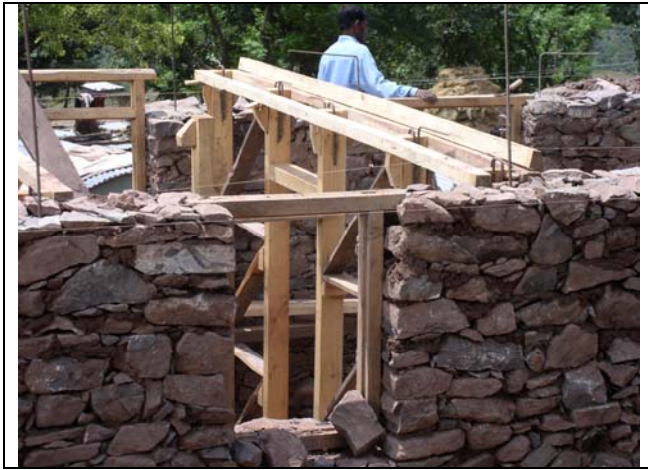
Shear connector between *Dhajji* wall and Eave Band

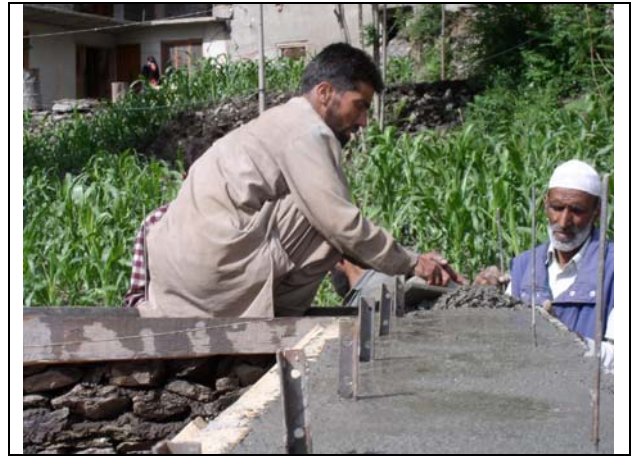
Installing MS angle and single rod connectors for roof structure anchoring in eave band

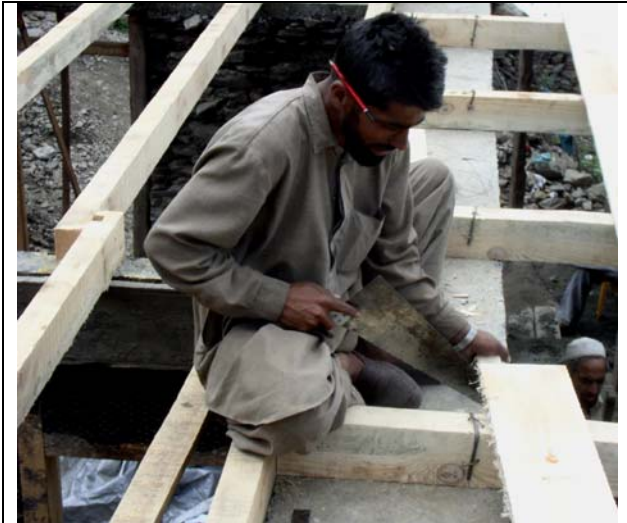
Installation of attic floor framing

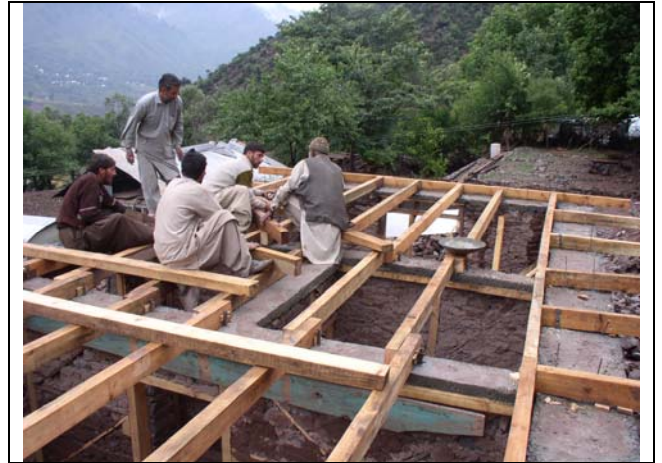
Anchoring roof deck to Eave Band
