**Transfer of Earthquake Resistant Building
Technologies At Grassroots in Kashmir**

Rajendra Desai, Structural Engineer

**International Conference on
Earth Construction**

August 23, 2007

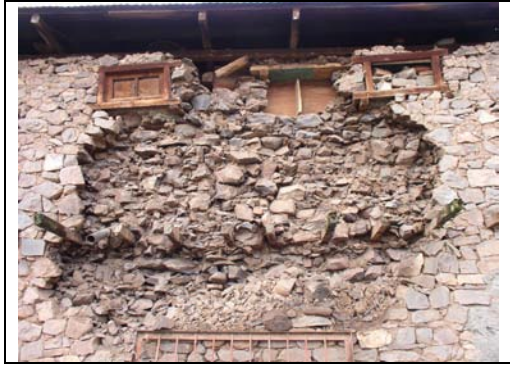
Delamination of UCR wall

No.	Descriptions	Cause
		to low rigidity in attic timber floor, absence of anchoring of attic floor to wall etc.
5	Bulging in UCR wall	Poor interlocking between outer and inner wythes of wall and absence of through stones
6	Delamination in UCR wall	Poor interlocking between outer and inner wythes of wall and absence of through stones
7	Collapse of a portion of wall	Excessive local damage resulting in to instability of a portion of wall
8	Cracking at lintel bearing	Inadequate bearing length and absence connection between the lintel and the band
9	Falling off of stone infill in Dhajji Diwar	Absence of containment of infill material
10	Collapse of <i>Dhajji Diwar</i>	Poor connection between <i>Dhajji Diwar</i> and base as well as ceiling
B	Roof & Floor	
1	Breaking of individual element	Rotten material
2	Collapse, partial or full	Lack of anchoring of roof to wall and collapse of support wall

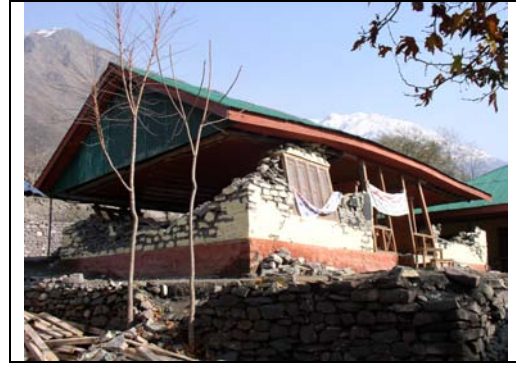
Collapse of UCR wall

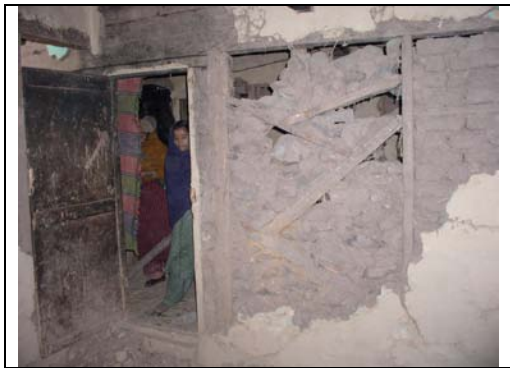
Damage to *Dhajji* wall infill

7	Cracking at lintel bearing	Adequate bearing length and connecting lintel and the band
8	Falling off of stone infill in Dhajji Diwar	Providing containment of infill material with chicken wire mesh nailed to wall faces
9	Collapse of <i>Dhajji Diwar</i>	Ensuring proper connection between <i>Dhajji Diwar</i> and bands
B	Roof & Floor	
1	Breaking of individual element	Better maintenance, anchoring of elements to wall bands

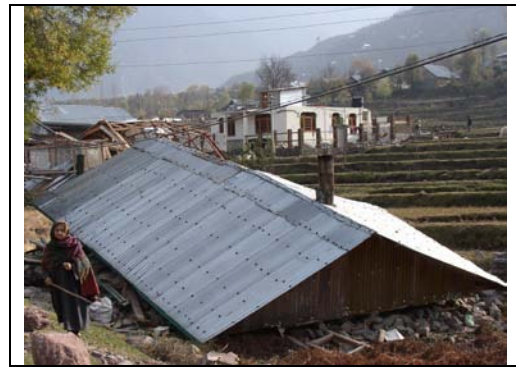
Roof box lying on ground

As in the earlier earthquakes in the subcontinent, the poor construction quality and absence of earthquake resisting features are the prime reasons for the damage. The basic laws of masonry construction including the rigor required by modern materials like cement and steel are routinely violated. This has contributed greatly to the vulnerability of structures. One observation that is peculiar to Kashmir earthquake is that the roofs have suffered little or no damage in many houses. The walls collapsed bringing the roofs down, often, in intact condition.

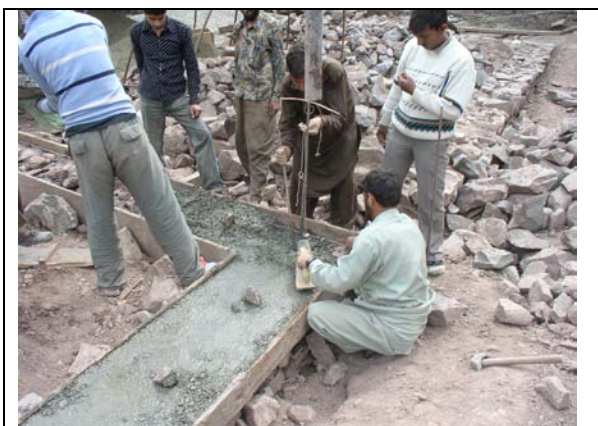
Shear keys on top of RC Band

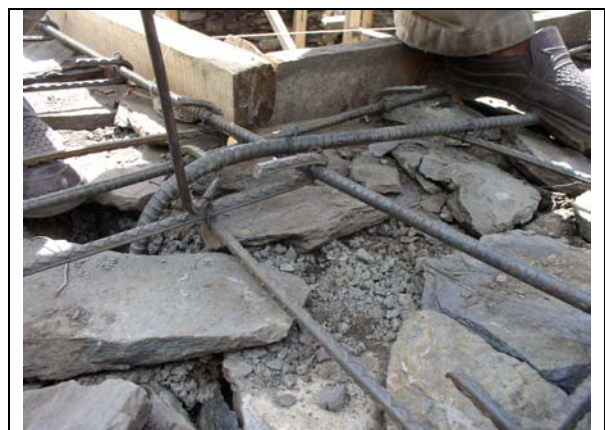
Connecting vertical reinforcement to RC Band

- **Vertical Reinforcement:** It was a great challenge to convince the trainees to a level that they are able to counter the demand for pseudo RC columns made by the house-owner. The resemblance between the behavior of a tree that generally withstands ground shaking and a house that has ductility induced by such reinforcement was used to convince them in favor of the vertical reinforcement against pseudo RC columns.

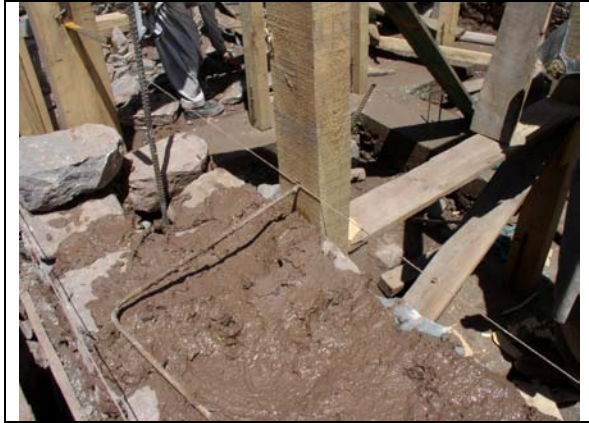
Dhajji wall anchor to UCR wall

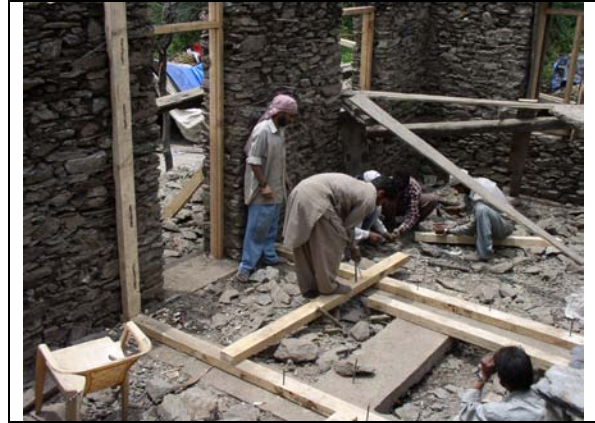
Dhajji wall anchored to Band & UCR Wall

- Simple anchoring of *Dhajji wall* to plinth band
 - Simple connection between *Dhajji wall* to eave band
 - Simple connection between eave band and attic floor deck

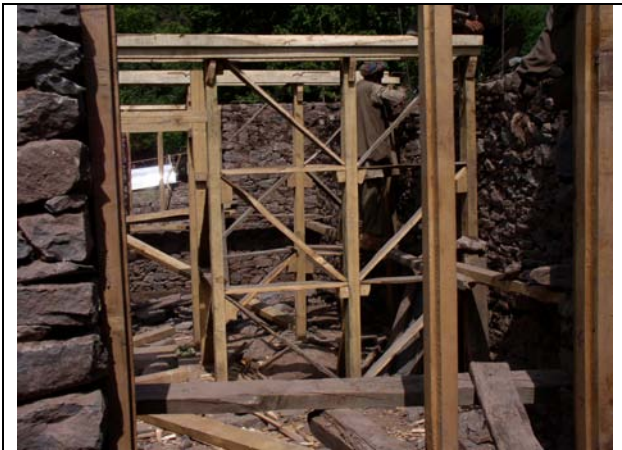
Dhajji wall with continuous bracings and improved connections

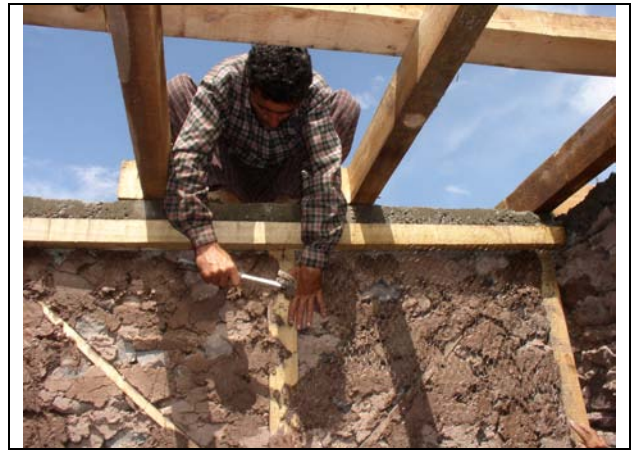
Chicken Wire Mesh confinement on *Dhajji* wall

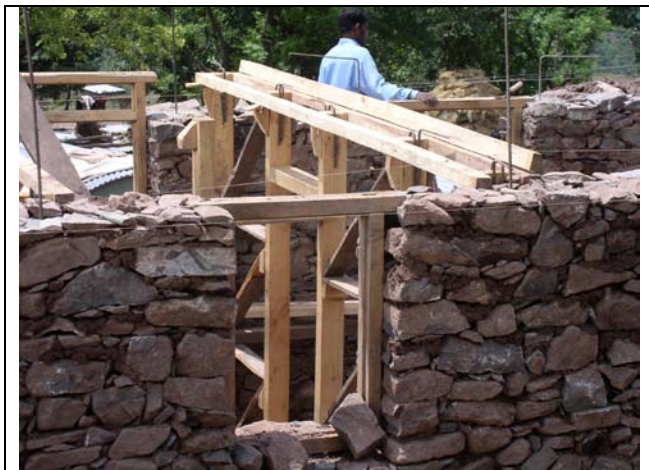
Shear connector between *Dhajji* wall and Eave Band

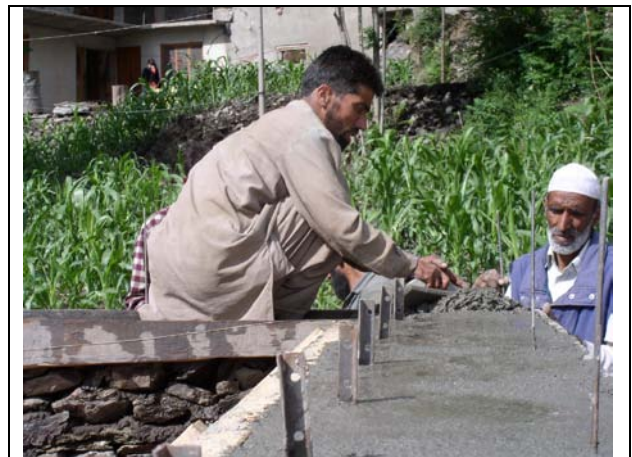
Installing MS angle and single rod connectors for roof structure anchoring in eave band

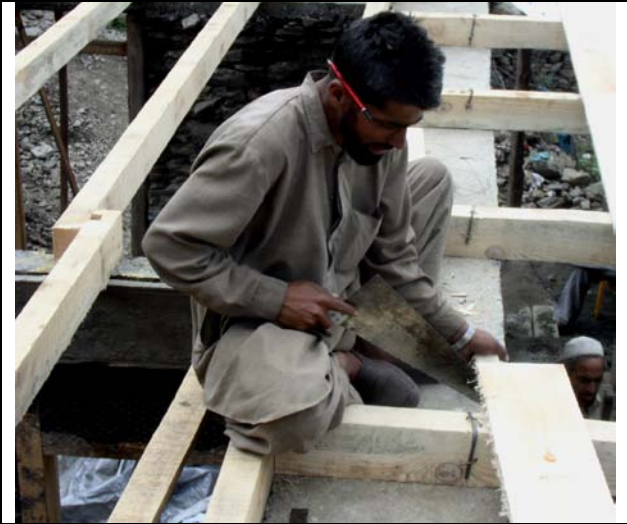
Installation of attic floor framing

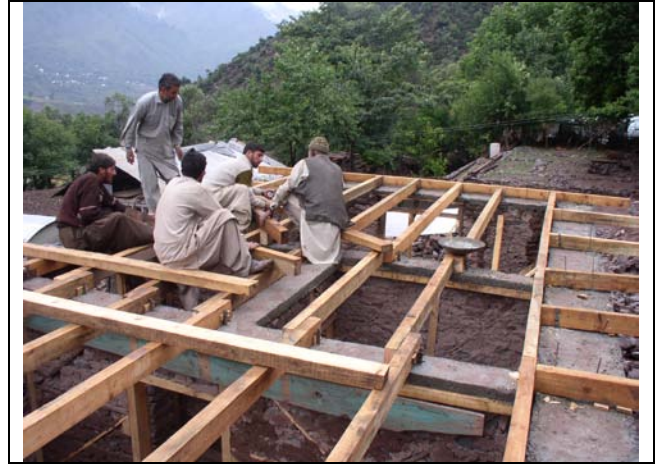
Anchoring roof deck to Eave Band
